ChemLINE® Ensures Safe Transportation and Product Purity for Hicri Ercili, Time After Time.

How the ChemLINE® Coating System Helps Hicri Ercili

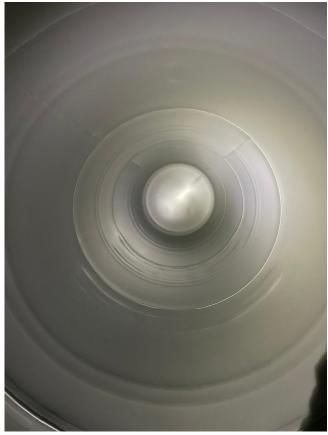
Final grey topcoat of the ChemLINE® ES coating system applied inside the OTR trailer by ChemLINE® Turkey.

One of the cargoes that HICRI ERCILI regularly transports in its fleet of the over-the-road (OTR) trailers is Sulphuric Acid, in this case, the concentration of Sulfuric Acid ranges between 70-98%. The OTR trailer was constructed from 304L stainless steel, and the customer was having issues revolving around impurities leeching into the product. Lab testing showed an increase in iron contents in the sulfuric acid solutions from the stainless steel, the leading cause of the product impurity.

HICRI ERCILI looked to ChemLINE® ES (Elevated Service) high-performance coating from Advanced Polymer Coatings for this chemical service. ChemLINE® is a lining system that is designed to handle many different types of hazardous and aggressive cargoes, and it has a long history of performance in the transportation industry.

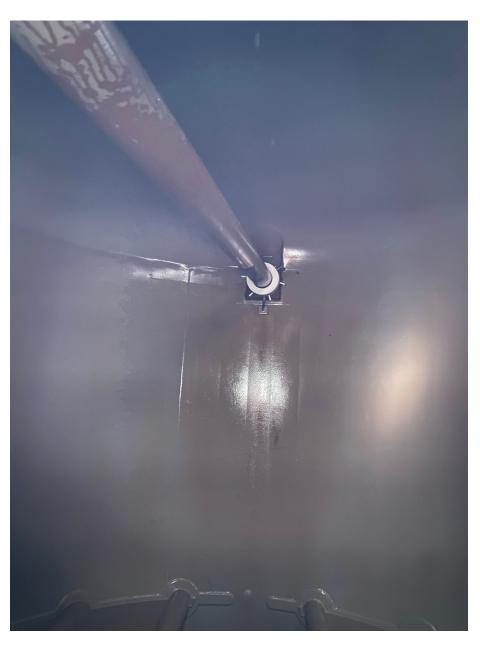
The ChemLINE® coating system has shown nearly 15 years of quality service inside this ISO Tank in sulfuric acid service, as shown in the images to the right.

Having witnessed the benefits of the ChemLINE® Coating System first-hand, HICRI ERCILI continued to trust the ChemLINE® Brand after the coating system demonstrated superior chemical resistance and longevity when applied to an ISO Tank they had purchased from Germany back in 2007.

Most industrial chemical transporters like ISO tanks due to their durability. An average ISO tank container life cycle runs between 15-20 years, while some can even go up to 35 years in business. With proper care and maintenance, the coating system applied inside the tank can also run the long game, as proven in this HICRI ECIRI tank shown here.
